TECHNICAL REPORT BRL-TR-2812

NITROGUANIDINE MORPHOLOGY  
IN EXTRUDED GUN PROPELLANT

ROBERT J. LIEB

US ARMY BALLISTIC RESEARCH LABORATORY  
ABERDEEN PROVING GROUND, MARYLAND

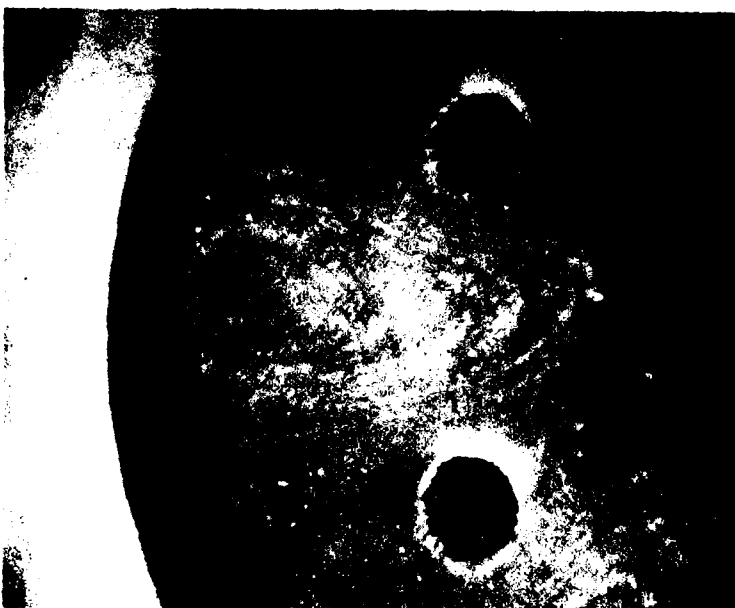
a. The Entire Grain End

b. Detail of Figure 1a.

Figure 1. Optical Photograph of M31A1 Lot 07077 Showing the Ring Structure between the Outer Perforations

The M31A1 specimen shown in Figure 1 was prepared for investigation using a scanning electron microscope (SEM). Figure 2 shows the resulting SEM photograph, and demonstrates the morphological nature of the rings. The long sweeping arcs are the result of machining required to flatten the end surfaces for testing. Higher magnification photos showed that each ring seemed to be a path formed by a series of voids. Since it was difficult to determine if the apparent porosity was intrinsic to the grain or generated by the preparation procedure, this grain was prepared for further investigation by being cold fractured along a line from midweb to midweb, through the middle of the ring structure and middle perforation. Fractures, such as this one, running through the center of opposite ring structures will subsequently be referred to as a Type A Fracture, which is illustrated in Figure 3. Cold fracturing is achieved by slowly cooling the grain in dry ice. A cold razor edge is then placed along a line defining where the crack is to begin, and a hammer strike initiates the crack propagation. The resulting crack exposes new surface that is neither stretched nor torn and, due to the brittle nature of the low temperature fracture, the inner structure of the material is revealed with little disturbance.

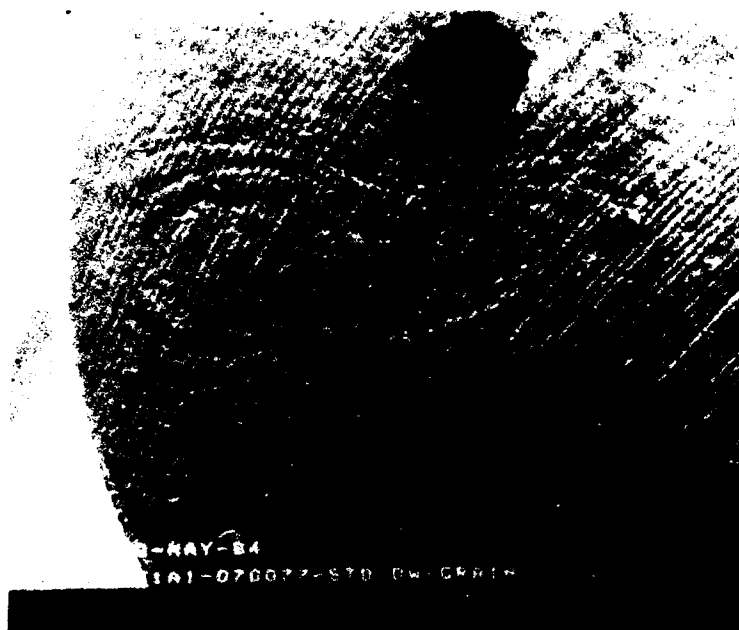
Figure 2. SEM Photograph of M31A1 Showing the Ring Structure

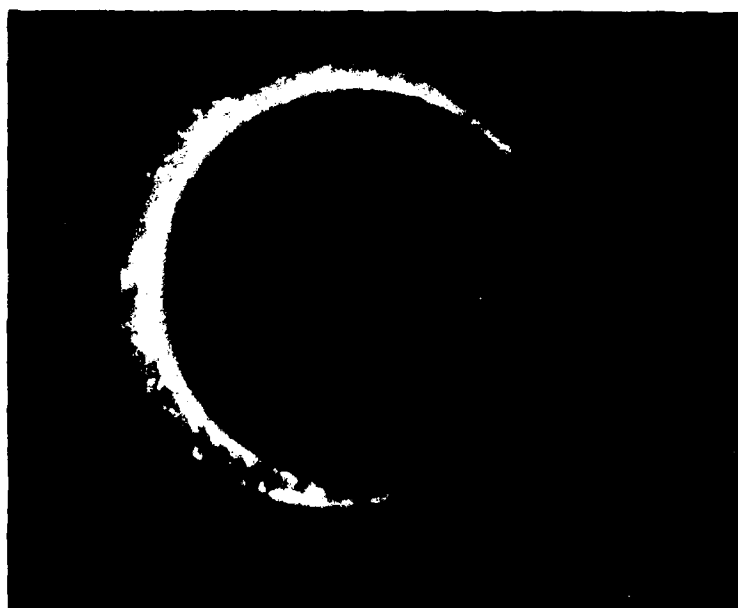
a. M30 with Normal NQ

b. M30 with Ground NQ

Figure 8. Photographs of M30 Solid Strand Extruded after Remixing and Pin Plate Removed
